New Technologies for Preventing Yankee Cylinder Edge Deposits

By Barry Bartles
Solenis UK Limited

Published:
Paper Technology | September 2015

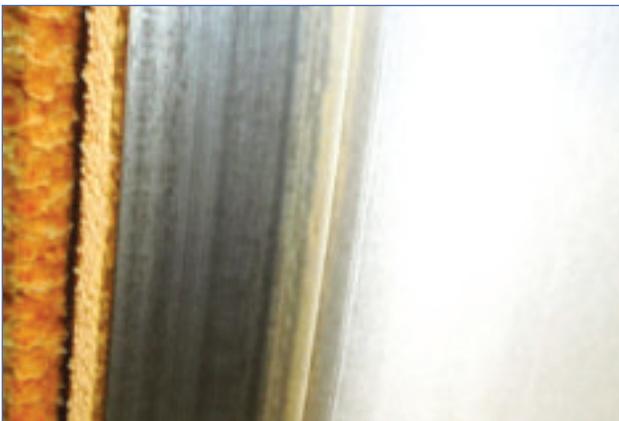
Figure 1: Hard brown deposits outside sheet area

Figure 1 shows typical edge deposit:

The darker brown deposits shown in the accompanying photographs have a higher percentage of oxidised polymers. This is probably from a build-up of chemical coating that becomes hard and is difficult to remove (this is especially true of crosslinking polymers, which can build up and oxidise). Lighter white deposits are mainly fines and short fibres; these can, with time, become hard and go brown due to oxidation at higher temperatures.

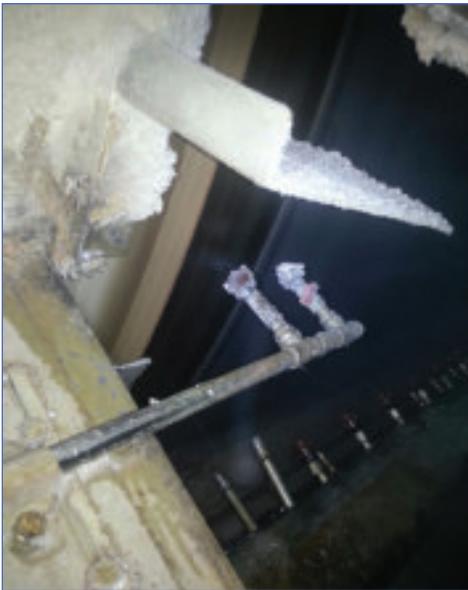
The mixing of the chemical with water can occur through a simple in-line mixer or a small mixing tank system. *Figure 3* shows a typical adjustable edge spray in use on a tissue machine.

Figure 3: Typical adjustable edge spray in use

3. Dedicated sprays, which can apply deposit-control chemicals just to the cylinder edge, are becoming a common approach — one that is proving to be very successful. The physical positioning of these dedicated sprays depends on the design and construction of the tissue machine drying section. The most common positions are just before the creping blade or after the blades and before the full-face coating shower. In either case, accessibility for both installation and maintenance needs to be considered carefully. Mill operators should ensure that the sprays are fully adjusted to maintain clearly defined coverage of the affected area, and to allow the spray nozzles to be moved for deckle changes, grade changes and routine maintenance of the tissue machine.

- The more common approach is a simple fan jet nozzle similar or identical to that used on the full-face shower. This is supplied with a mixture of water and chemical at a pressure of around 3 bars and a typical flow of approximately 0.45lpm through a 110° nozzle tip.
